123 Main Street Anywhere, NY 12345

Inspection Date:

1/12/10

Report Number:

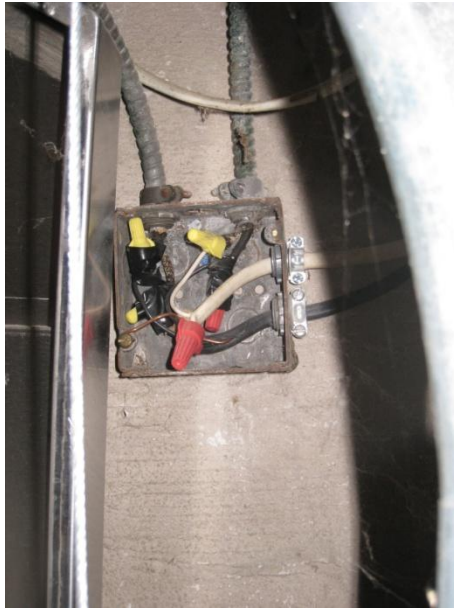
The fire separation wall was damaged and in need of repair. Refrigerator/freezer should not have GFCI. **Open junction box in garage with live wires this is a SAFETY HAZARD. Recommend having repaired by licensed electrician.**

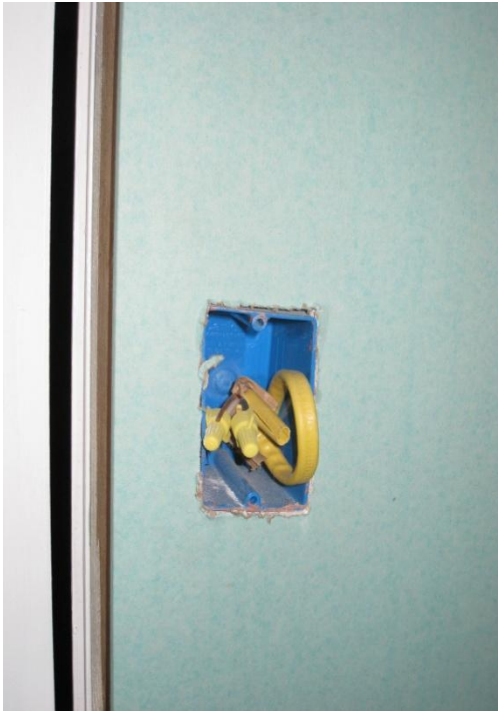
Cross connection present - grey water could be forced back into the water system - Safety Concern. Open switch box with live wires - SAFETY HAZARD

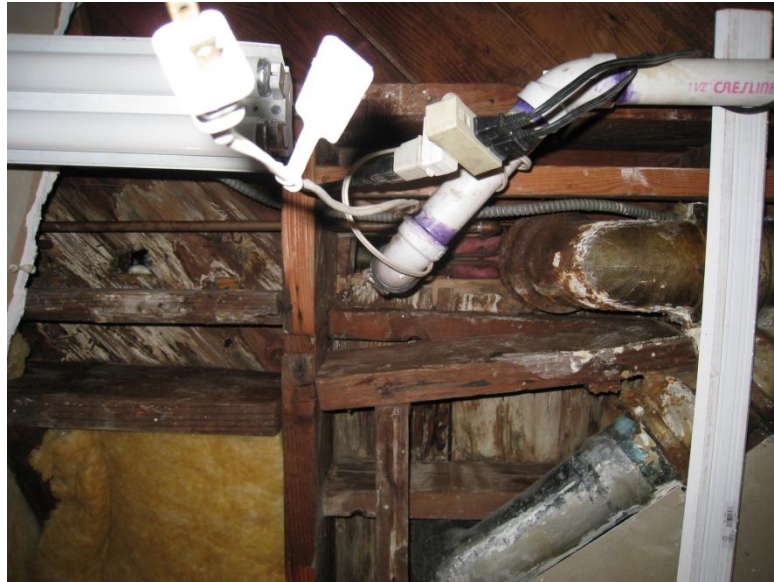
drain not visible. Visible floor joist in garage under upstairs bathroom has been notched improperly - re-support as necessary. Area around shower stalls have old moisture stains present. Area around toilets have old moisture stains present. These areas are dry at time of inspection – tested with moisture meter.
